# Stage 1 Further Investigation of Enclosure Wall in Nga Tsin Wai Village

Further Investigation of Enclosure Wall in Nga Tsin Wai Village Report

Archaeological Assessments Ltd.

Final Version February 2023

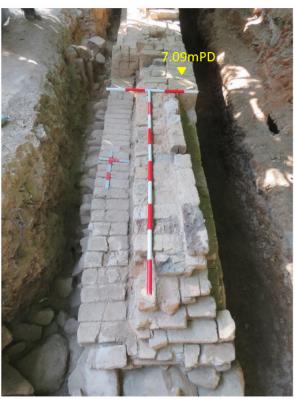
The brick wall height is preserved to seven rows (top sits at 7.09mPD), although the top bricks are in poor condition. Furthermore, the top three rows of bricks appear to have been bonded with a beige mortar. The exterior of the brick wall shows white pointing. The brick wall was incorporated into later use and has for instance, an alcove on the exterior with concrete render (Figure 18). The brick wall construction consists of flat and upright headers on the bottom (to create flat base) followed by flat headers, three rows of stretchers and again flat header.

Figure 18 view of the brick wall in Area NE with alcove on the right and strategically removed brick on the left; looking west.

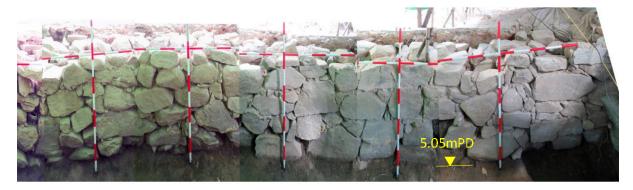
Figure 20 View of Area SC village wall (looking north), note the drain outlet (with ceramic pot) on the left.

Area SC is located between Lanes 1 and 2. Lane 1 area was excavated during the 2018 Further Investigation and a stone drain outlet was recorded in the south village wall. The village wall was recorded immediately under the modern surface and was uncovered to a height around 1.6m (**Figure 20**). The stone village wall consists of mainly large stones with smaller ones in between and is preserved to its full height. The exterior along the west section cannot be described as smooth but it does present as original.

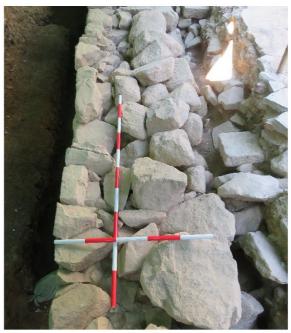
On the interior of the stone village wall and at the preserved (full) height a stone infill continues to the interior (**Figure 21**). No brick wall survived, and some modern granites, remains of later use and bonded to the village wall with concrete, were removed.

Figure 21 View of south village wall and stone infill on interior; looking west.

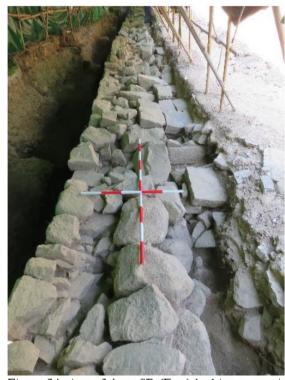
Figure 24 view of Area SB (East) looking west with floor stones on interior of village wall.

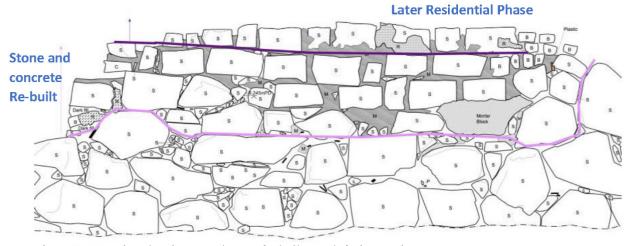
The upper row of stones consists of rectangular granite blocks and has a slightly different angle to south village wall. The three rows below are rebuilt using original medium stones and some rectangular granite with a white concrete or light pink concrete mortar in between. (**Figure 25**)

The latter section corresponds to major concrete area and stone within the moat. It is likely that this section was rebuilt to support a new residence to sit on top of the village wall and moat. The bottom part of the uncovered wall appears original with large stones and small ones in between.

Figure 25 Drawing showing two phases of rebuilt; south facing section.

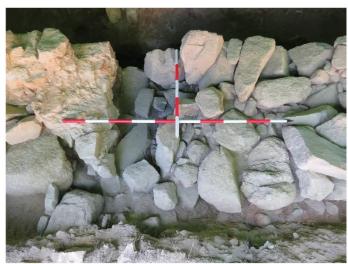
At the end of Lane 3, a modern ceramic drainpipe was recorded set within repurposed old drain in the stone village wall (**Figure 26**). The base of the stone drain outlet sits at a depth of 5.92mPD.

Figure 26 View of disturbed old stone drain; looking south.

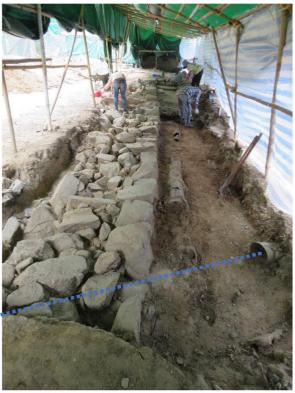
The plastic pipe [SF22] truncates the village wall at an angle (NW-SE) and extended into the moat area. Furthermore, an unconnected ceramic pipe (similar to what was excavated in the drain of Lane 3) was recorded at shallow depth parallel to the village wall, but overall, very little occurs within Area SA in moat and after moat infill. (Figure 29)

Figure 29 Excavation in progress showing ceramic pipe parallel to village wall and note partially removed plastic pipe [SF22] which extended over village wall; looking east.

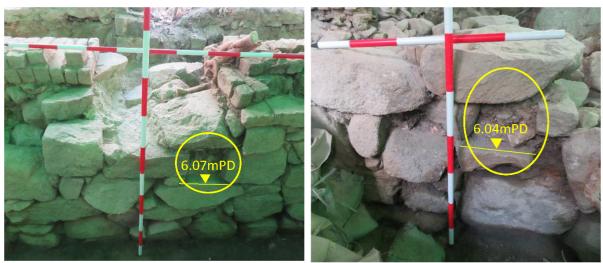
At the end of Lanes 5 and 6, stone drains were recorded within the stone village wall. The base of the stone drain at Lane 5 sits at a depth of 6.07mPD (and has a modern drain disturbance on top) (Figure 32) and the stone drain at Lane 6 sits at a depth of 6.04mPD (Figure 33).

Figure 32 Drain outlet at Lane 5 and modern Figure 33 Drain outlet at Lane 6 disturbance on top

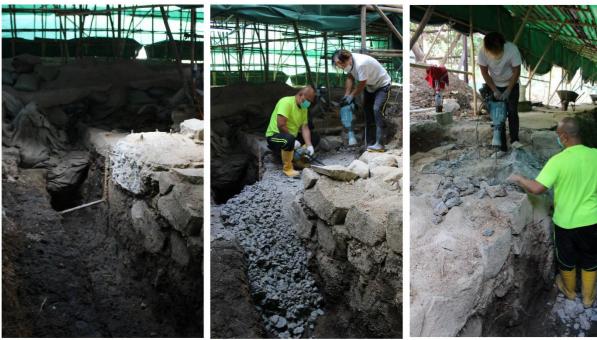
The village wall shows patched of hard white mortar in the disturbed top; it is possible that this disturbance occurred as part of the foundation construction. The west village wall section of Area SE is preserved to a significantly lower height than the concrete cover on current surface.

Figure 35 Concrete footing disturbing the village wall and removal of the concrete

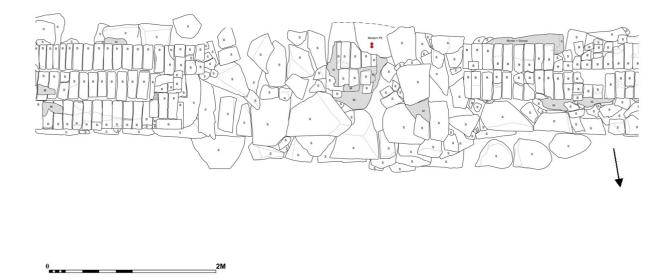
The top of the stone village wall is disturbed along many sections within the north and south trench. The disturbance is linked to village activities (residential construction) after the infill of the moat and loss of enclosure wall as defence item. The exception is a supposed rebuilt stone village wall section in Area ND (East) within the north trench. The rebuilt section has a thickness of 1.6m and protrudes into the moat (**Figure 38**). The stones used in the rebuilt do not differ from original stone village wall and the surrounding stratigraphy does not give evidence to when or why the rebuilt occurred but it is clear that the rebuilt section does not truncate the moat fill in. Furthermore, the brick wall remnants recorded along the west in Area ND extend over the rebuilt section (**Figure 38**).

Figure 38 Plan of rebuilt village wall section in ND (East).

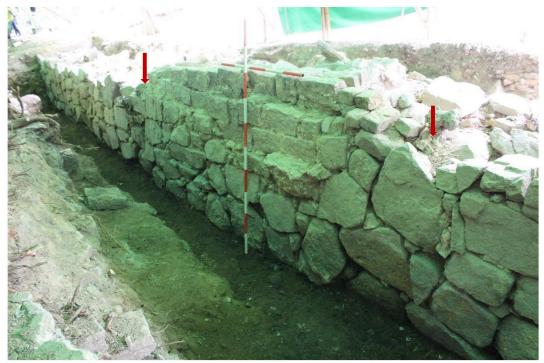
Within the south exterior stone village wall possible 'construction sections' are noted, whereby the wall would have been constructed in segments rather than conceived as a continuous structure (**Figures 39-40**). This was however, not noted in previous uncovered wall section or within the north trench. The uncovered height of stone village wall in north trench is limited (between 0.6 and 0.8m) and as such divisions may be hard to spot.

Figure 39 South village wall showing possible sections in construction.

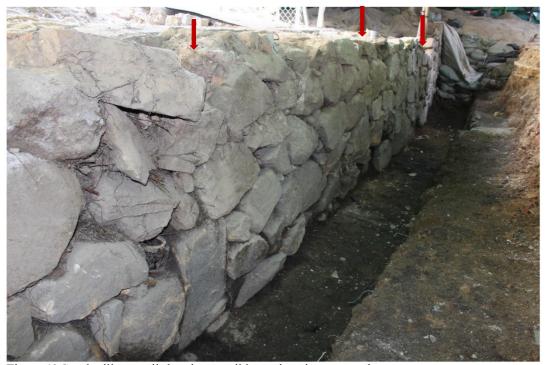
Figure 40 South village wall showing possible sections in construction.

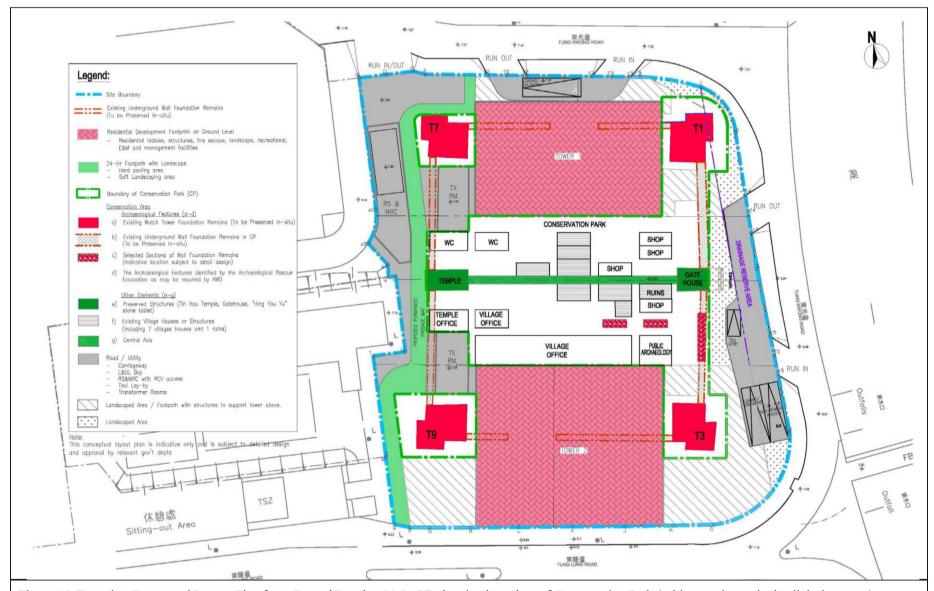
Figure 46. Tentative Conceptual Layout Plan from Ground Level to 21.9mPD showing boundary of Conservation Park (subject to change in detail design stage)
